WARNING

Care should be taken when installing any switchboard.

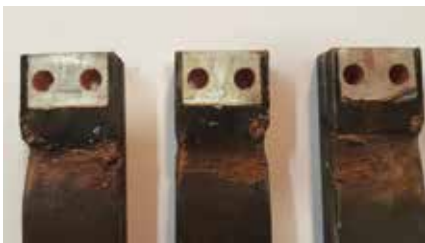
Fig. 1: Arc fault damage

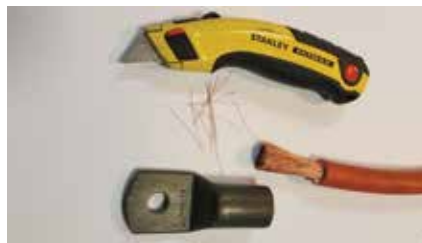
Fig. 2: Incorrect tool
